**CARBON FIBER INSTALLATION AT  
INTERMOUNTAIN POWER SERVICE  
CORPORATION  
UNIT 1 - MARCH 1988  
84", 114" & 120" Diameter PCCP  
Pipe Sections**

**CARBON FIBER INSTALLATION REPORT**

**COOLING WATER SYSTEM – UNIT 1**

**KPFF CONSULTING ENGINEERS, INC.**

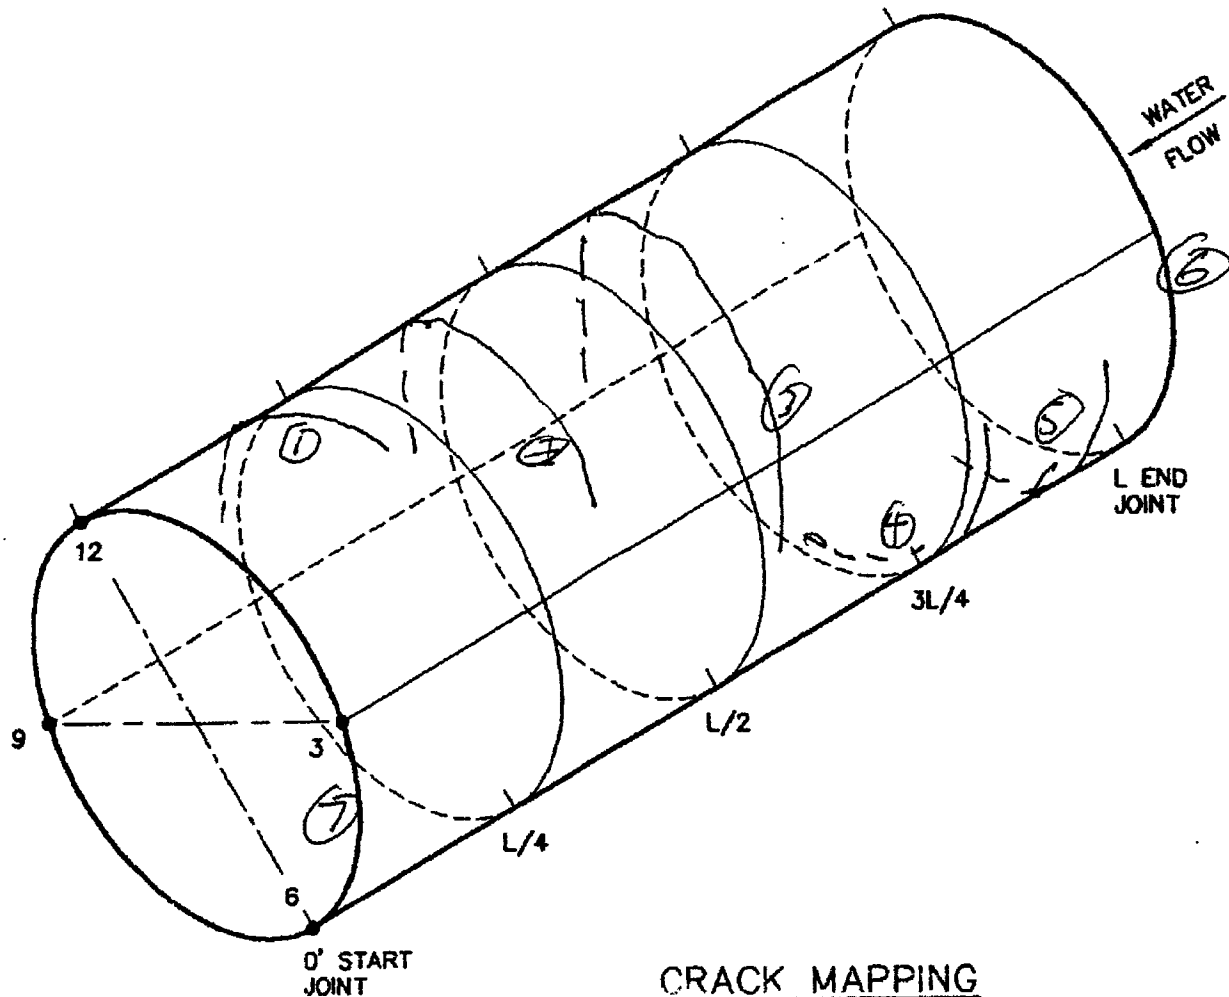
CRACK MAPPING

CRACK NO.	LOCATION	DESCRIPTION	REMARKS
1	L/4	11-1	3'-0"
2	3L/8	11-3	6'-0"
3	L/2	9-5	13'-0"
4	3L/4	4-7	moisture coming thru 5'-0"
5	7L/8	4-7	moisture coming thru 5'-0"
6	JOINT		22'-0"
7	JOINT		22'-0"

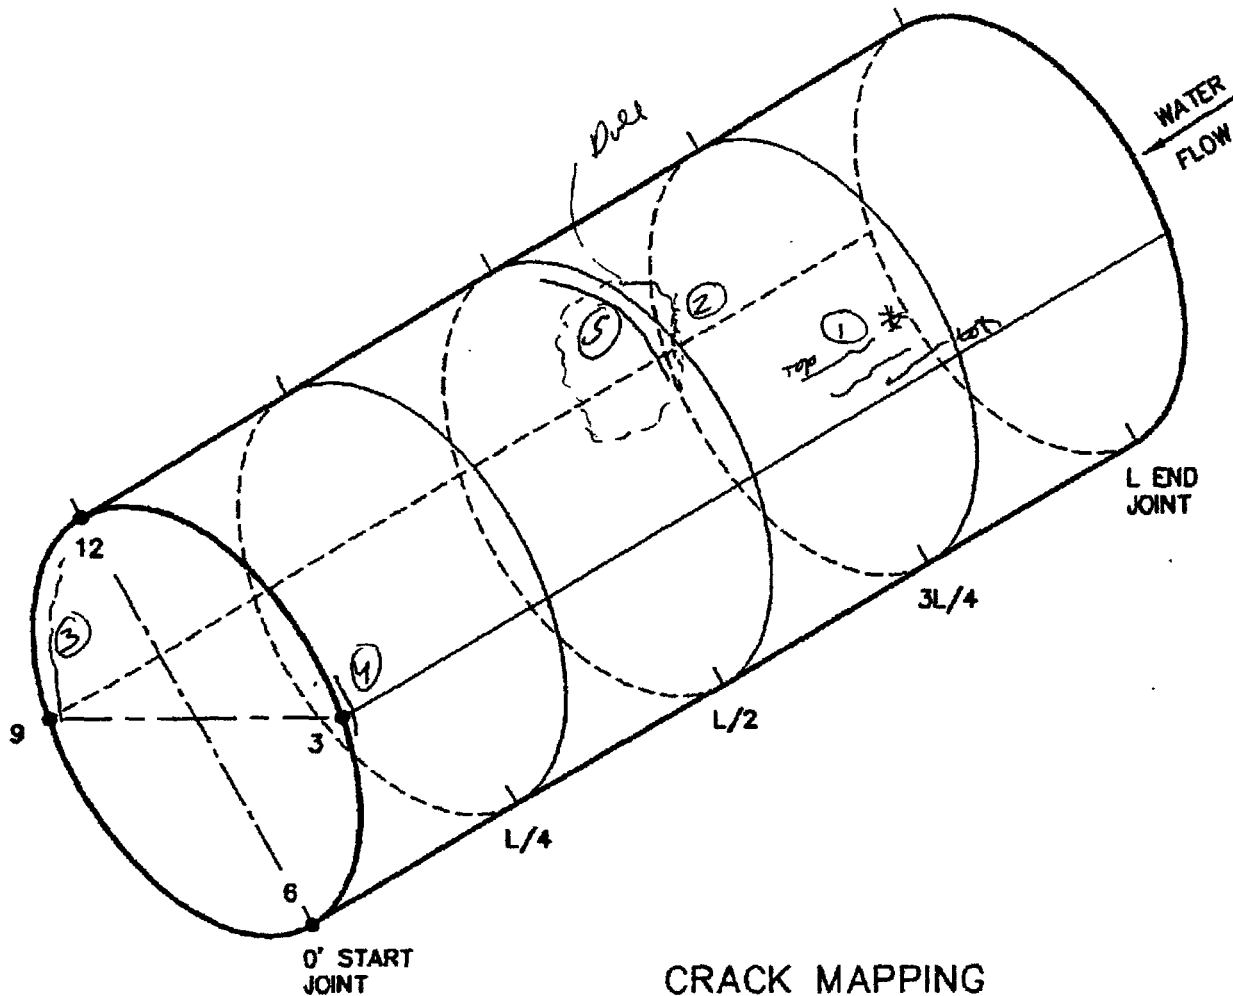
CRACK MAPPING  
23'

CRACK NO.	LOCATION	DESCRIPTION	REMARKS
①	@ 3L/4 top: 1'-3" middle: 2'-8" bottom: 5'-7"	micro horiz. cracks	
②	3L/4 1'-7"		
③	9-11 6'	JT. CRACK	
④	2-3 4'	JT. CRACK	
⑤	1-2 4'	MICRO CRACK

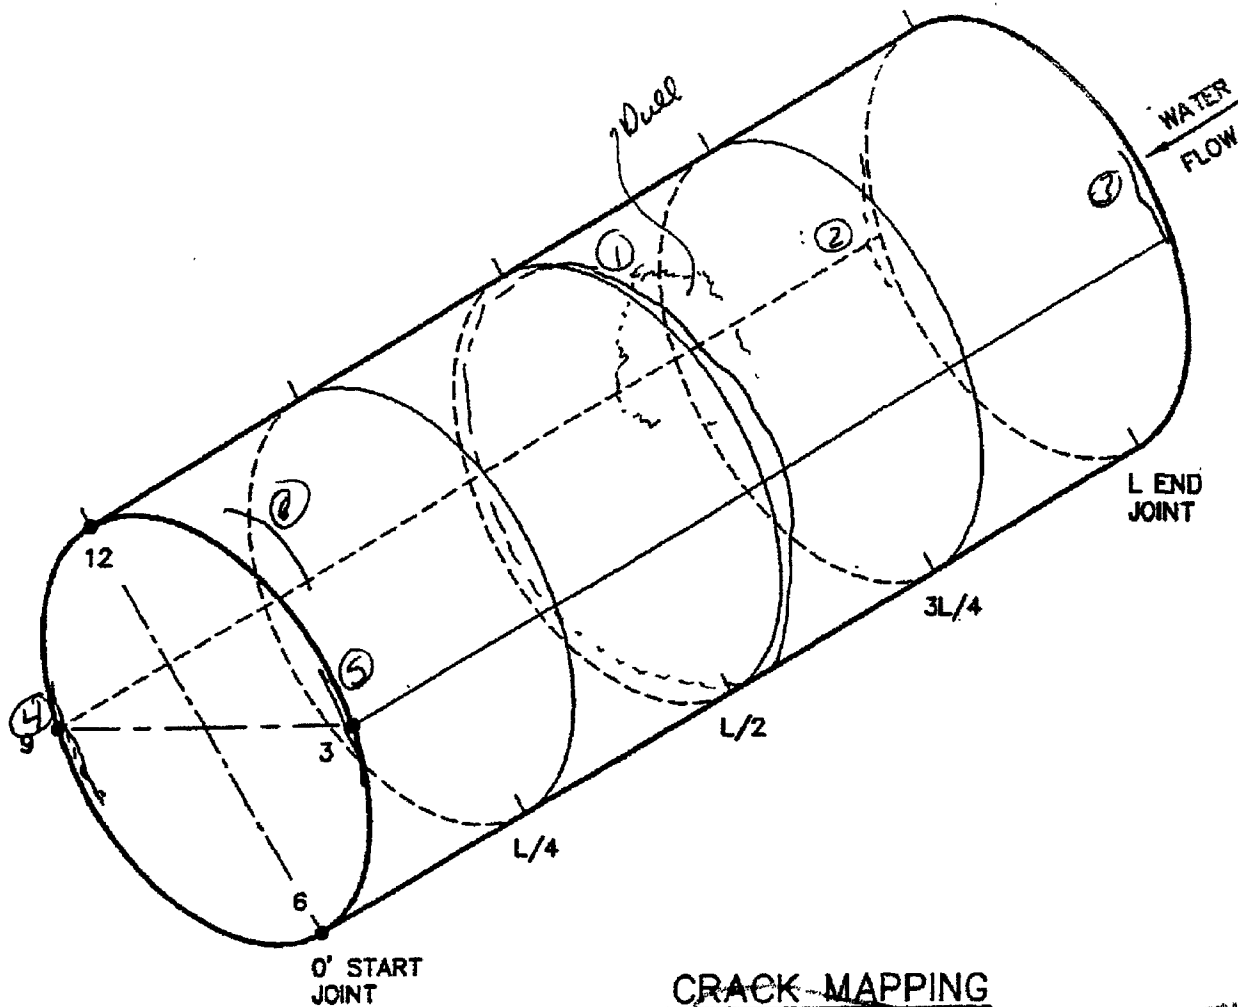
# CRACK MAPPING

CRACK NO.	LOCATION	DESCRIPTION	REMARKS
①	L/2	hoop crack microcrack circ.	
②	joint (end) 18"		
③	joint (end) 18"		
④	joint (start) 2'-4"		
⑤	joint (start) 2'		
⑥	MICRO CRACK	1'-2 3'

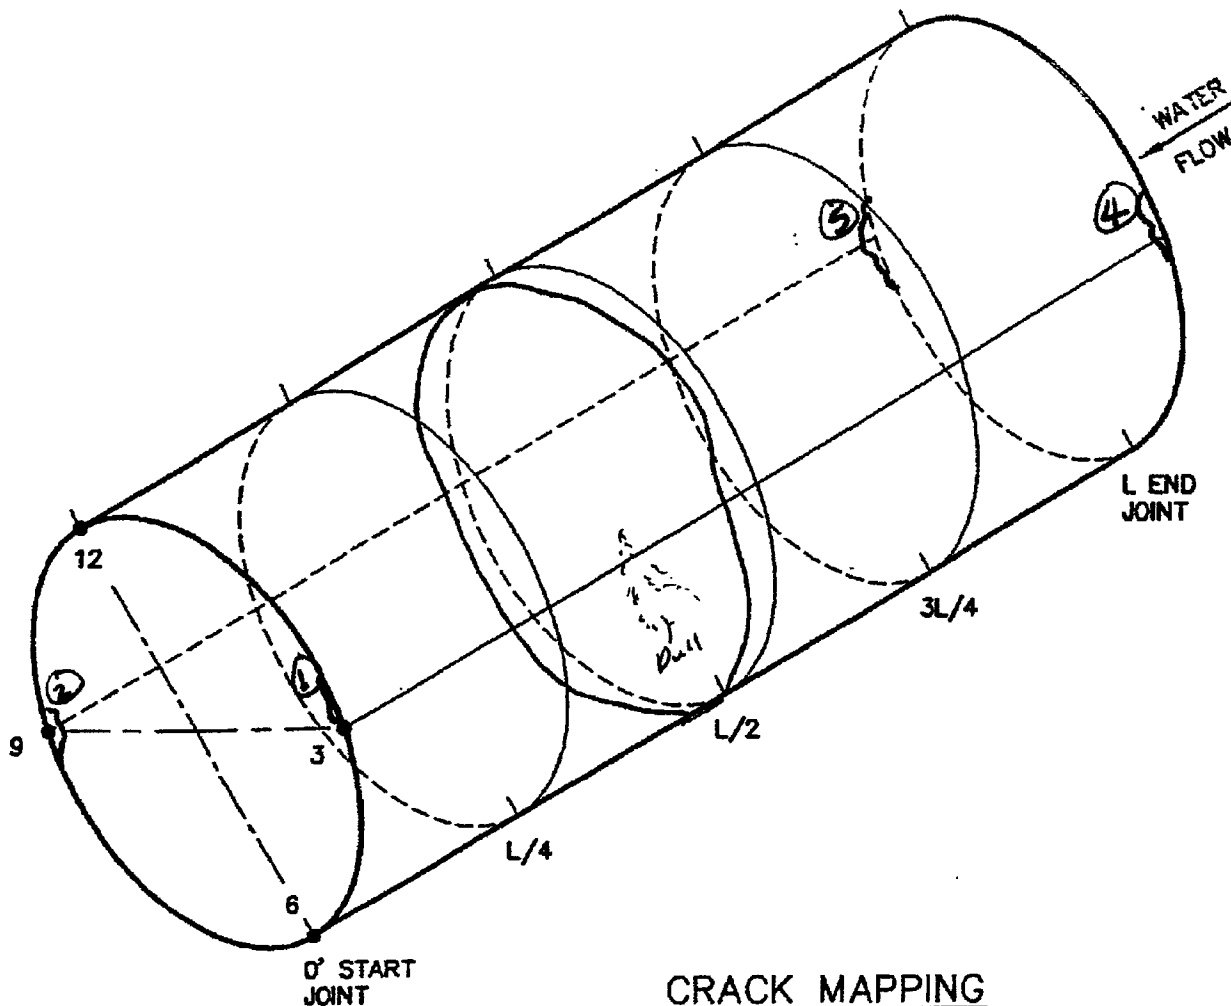
# CRACK MAPPING

CRACK NO.	LOCATION	DESCRIPTION	REMARKS
①	@ Start joint 3:00	JOINT CRACK 19"	
②	@ Start joint 9:00	JOINT CRACK 18"	
③	@ $4\frac{1}{2}$ Pull circumference	HOOP CRACK	
④	@ end joint 3:00	JOINT CRACK 40"	
⑤	@ end joint 9:00	JOINT CRACK 30"

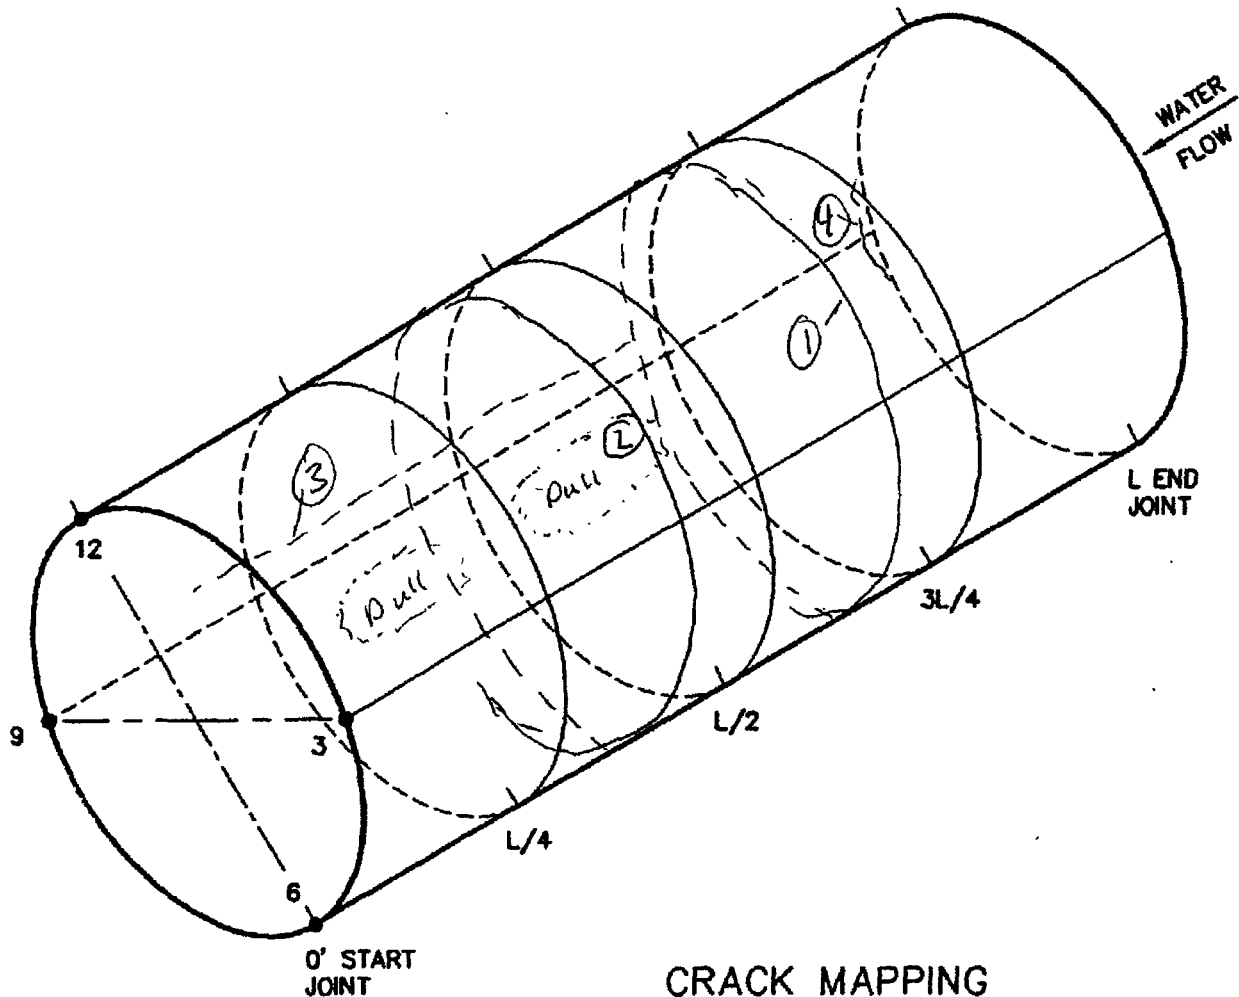
CRACK MAPPING  
77' = 924"

CRACK NO.	LOCATION	DESCRIPTION	REMARKS
①	4/2 - 3L/4 12h	spiral crack	<del>later to be removed</del>
②	4/4 - 4/2 12h	spiral crack	
③	9 o'clock 3L/4 to mid start	length crack	8 feet
④	<del>for 1/4</del> 8 to 10 o'clock L END	joint crack	2 feet

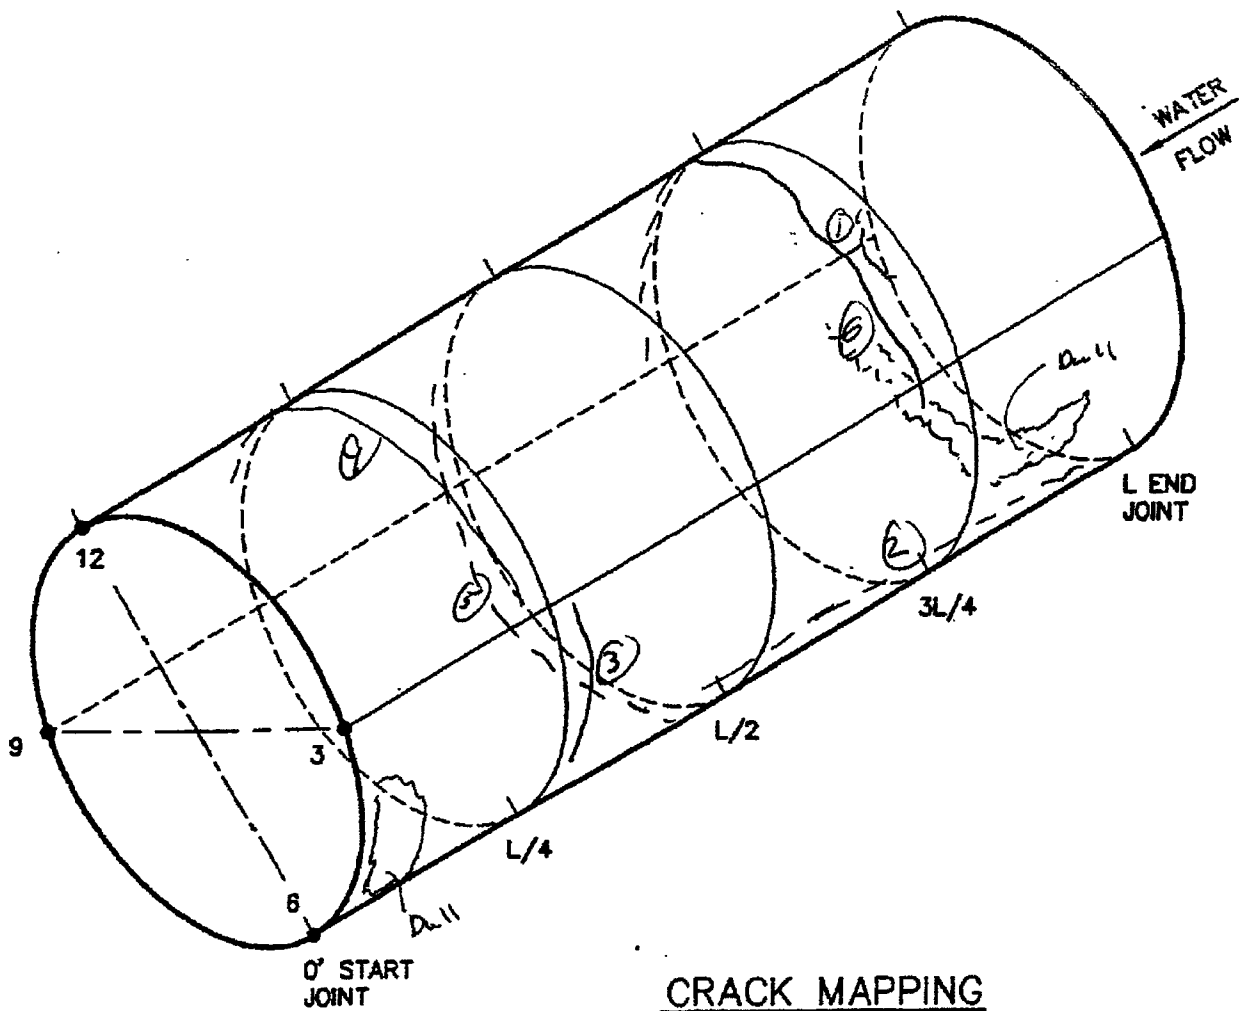
# CRACK MAPPING

CRACK NO.	LOCATION	DESCRIPTION	REMARKS
①	9 2'	JT. CRACK	
②	6 8'	MICROCRACK	
③	3.5 5'	MICROCRACK	
④	11.3 10'	MICROCRACK	
⑤	6-10 10'	MICROCRACK	
⑥	9-4 15'	MICROCRACK

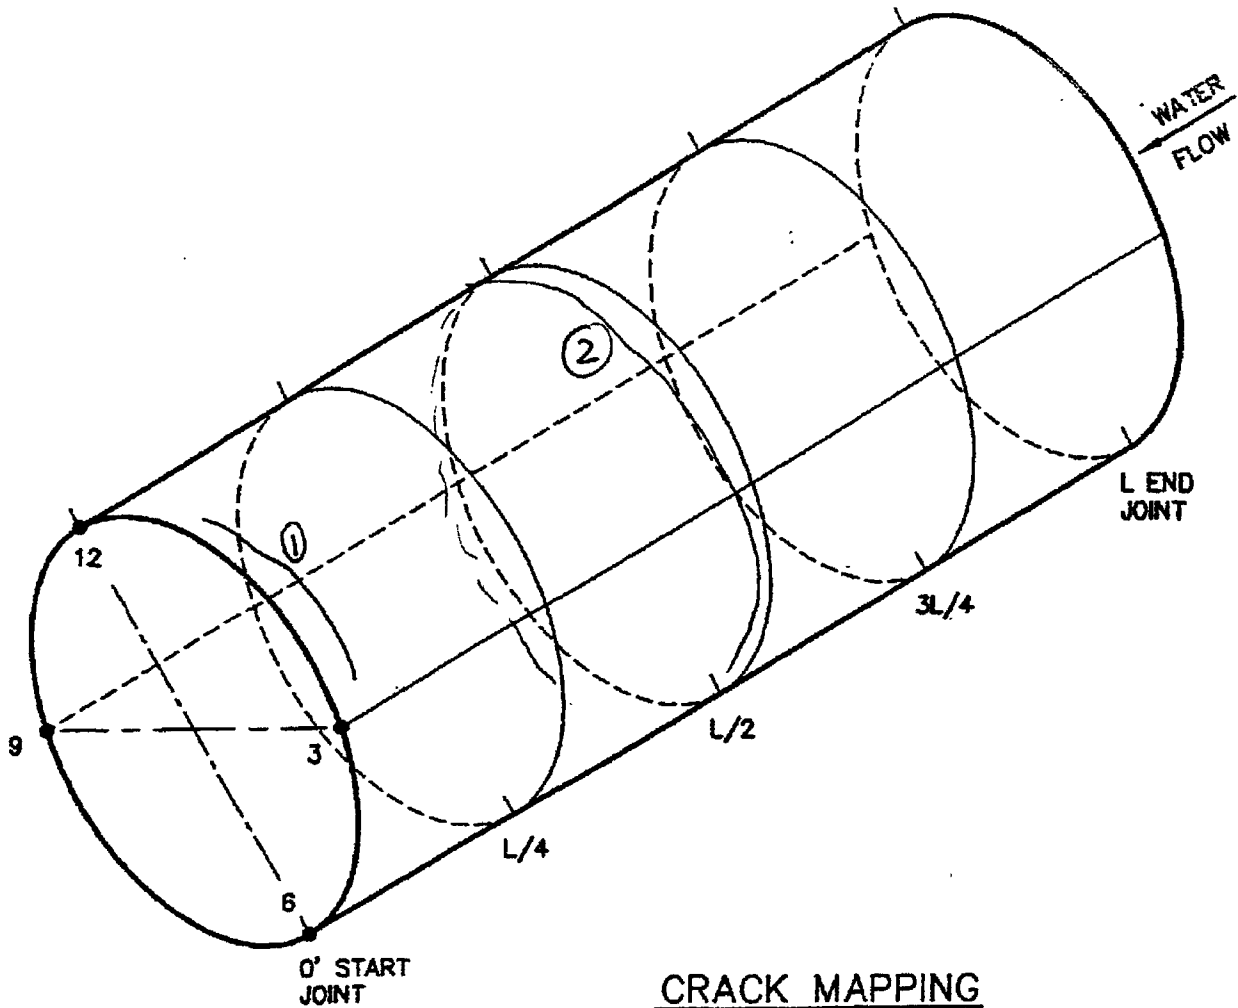
# CRACK MAPPING

CRACK NO.	LOCATION	DESCRIPTION	REMARKS
①	1-3 5'	MICROCRACK	
②	7-4 25'	HOOP CRACK

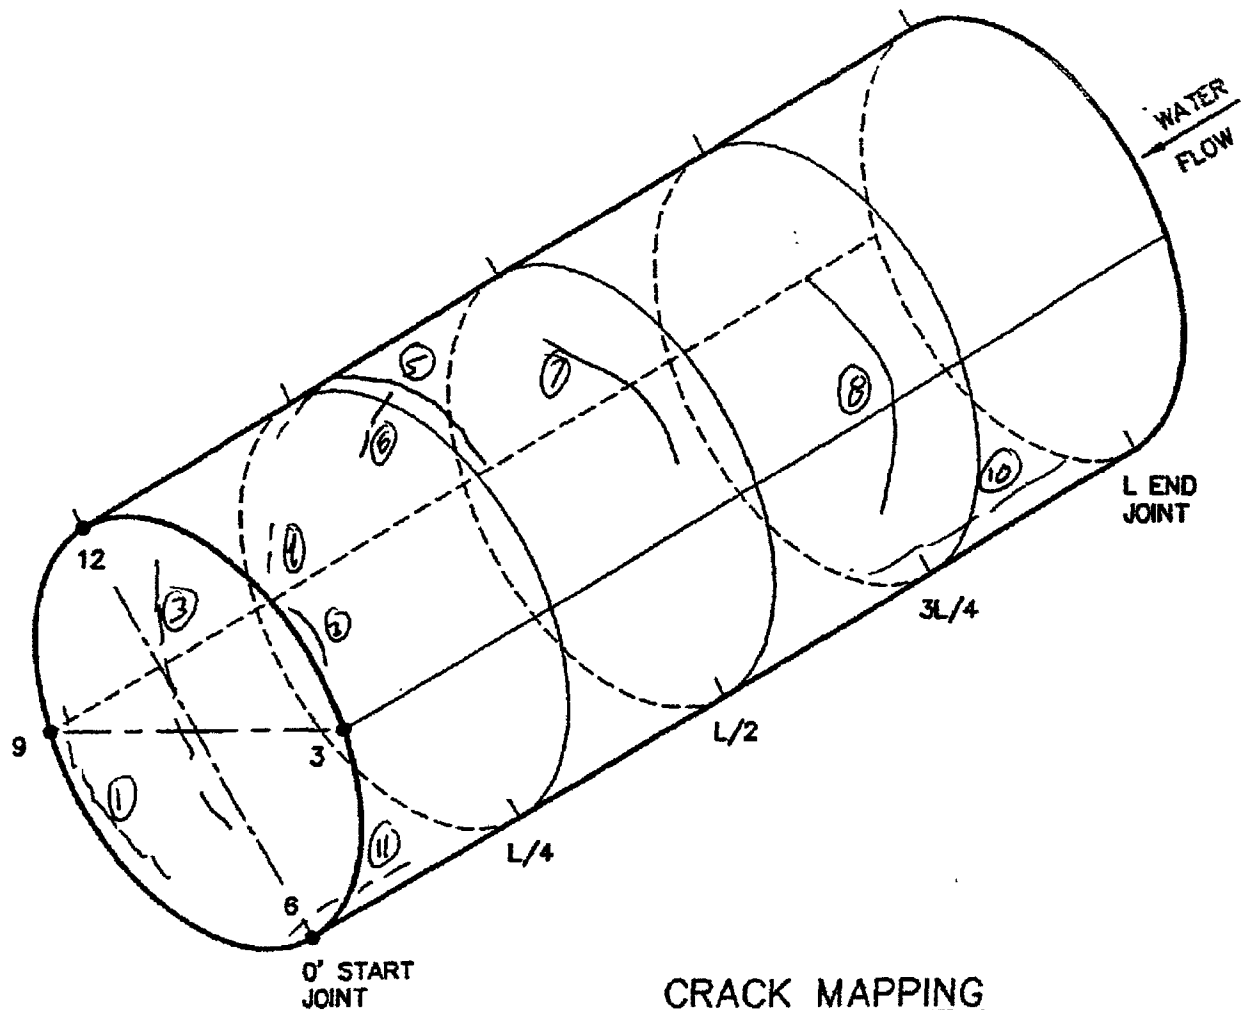
# CRACK MAPPING 58' ✓

CRACK NO.	LOCATION	DESCRIPTION	REMARKS
①	7-9 5'	JT. CRACK	
②	2 2'	JT. CRACK	
③	8-10 8'	MICROCRACK	
④	10 1'	MICROCRACK	
⑤	11-1 6'	MICROCRACK	
⑥	10 2'	MICROCRACK	
⑦	1-2 4'	MICROCRACK	
⑧	2-4 4'	MICROCRACK	
⑨	8-1 15'	MICROCRACK	
⑩	6 8'	CRACK W/ EPOXY	PATCH
⑪	6 3'	MICROCRACK

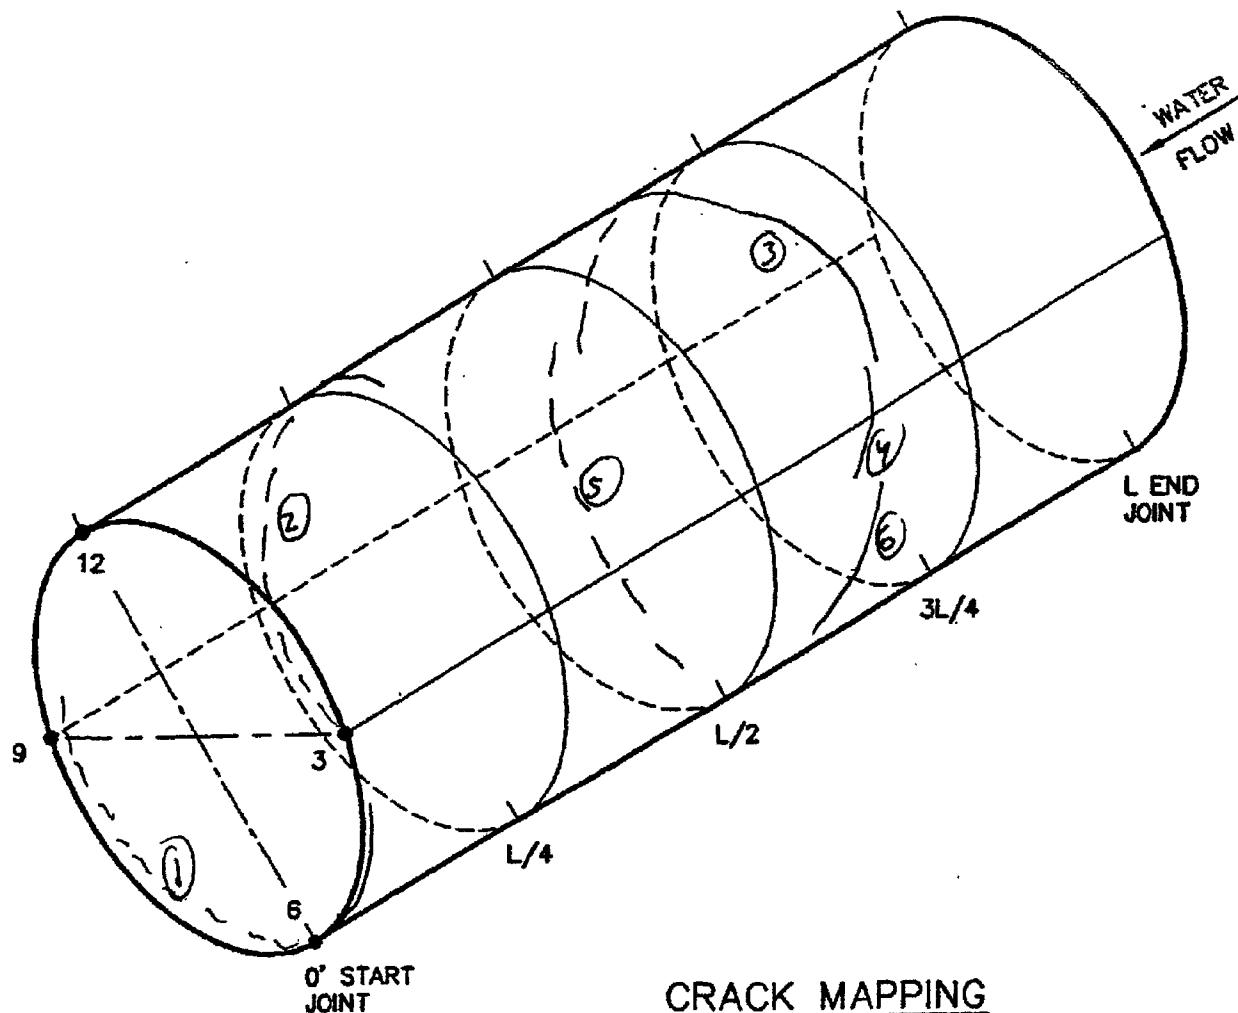
# CRACK MAPPING

CRACK NO.	LOCATION		DESCRIPTION	REMARKS
①	9-10	15'	JT. CRACK	
②	7-2	18'	MICROCRACK	
③	10-2	12'	MICROCRACK	} 3, 4, 5, & 6 HOOP CRACK
④	2-3	3'	MICROCRACK	
⑤	7-10	6'	MICROCRACK	
⑥	4-6	16'	MICROCRACK

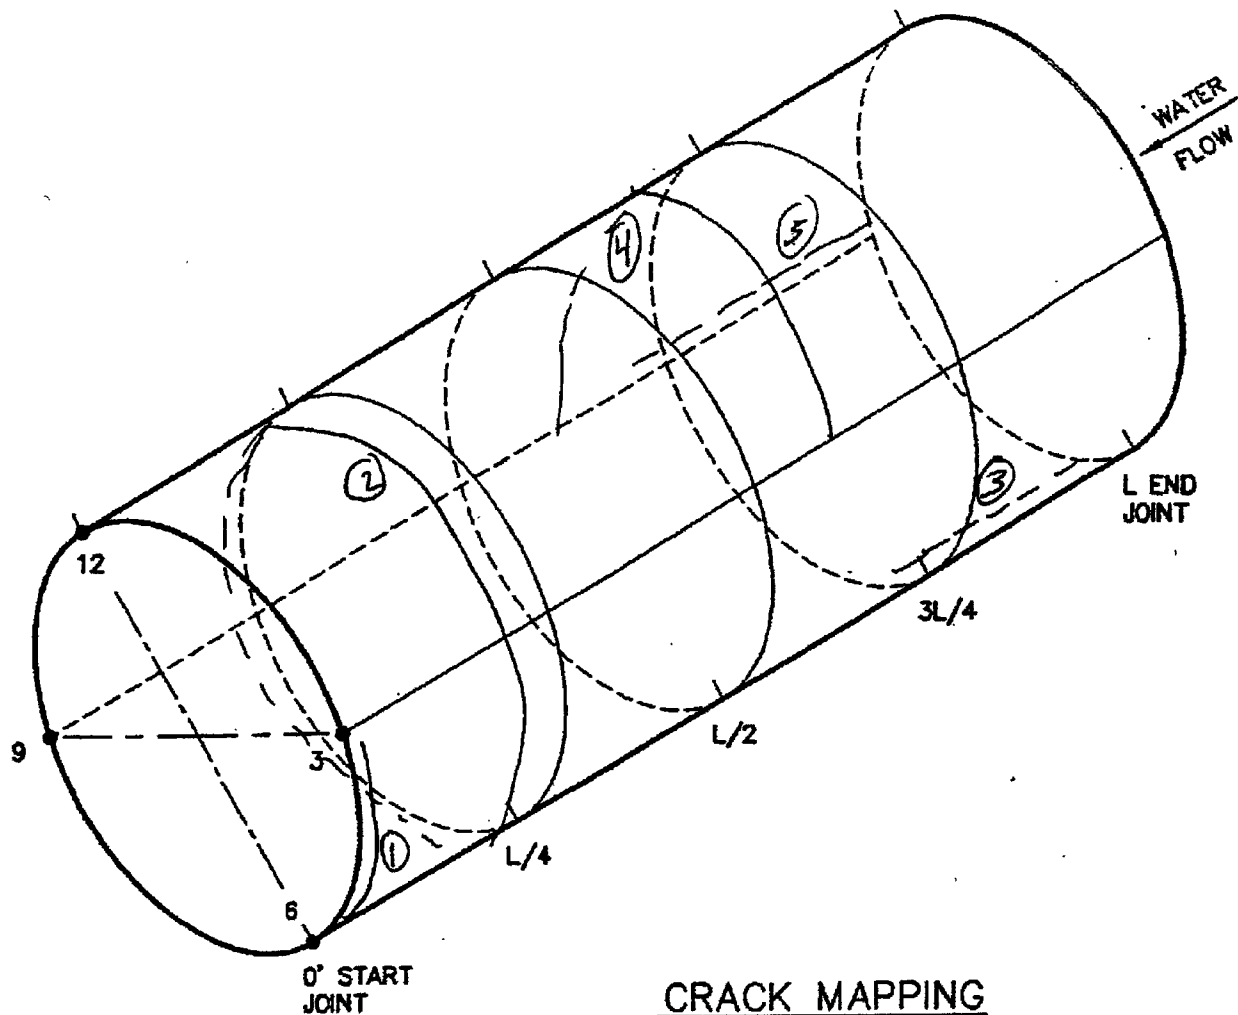
# CRACK MAPPING

CRACK NO.	LOCATION	DESCRIPTION	REMARKS
(1)	4-6 8'	JT. CRACK	
(2)	12-12 32'	HOOP CRACK	
(3)	6 6'	LARGE CRACK	PATCH (BPT)
(4)	9-3 15'	MICROCRACK	
(5)	9 8'	LONG. CRACK	PATCH (BPT)

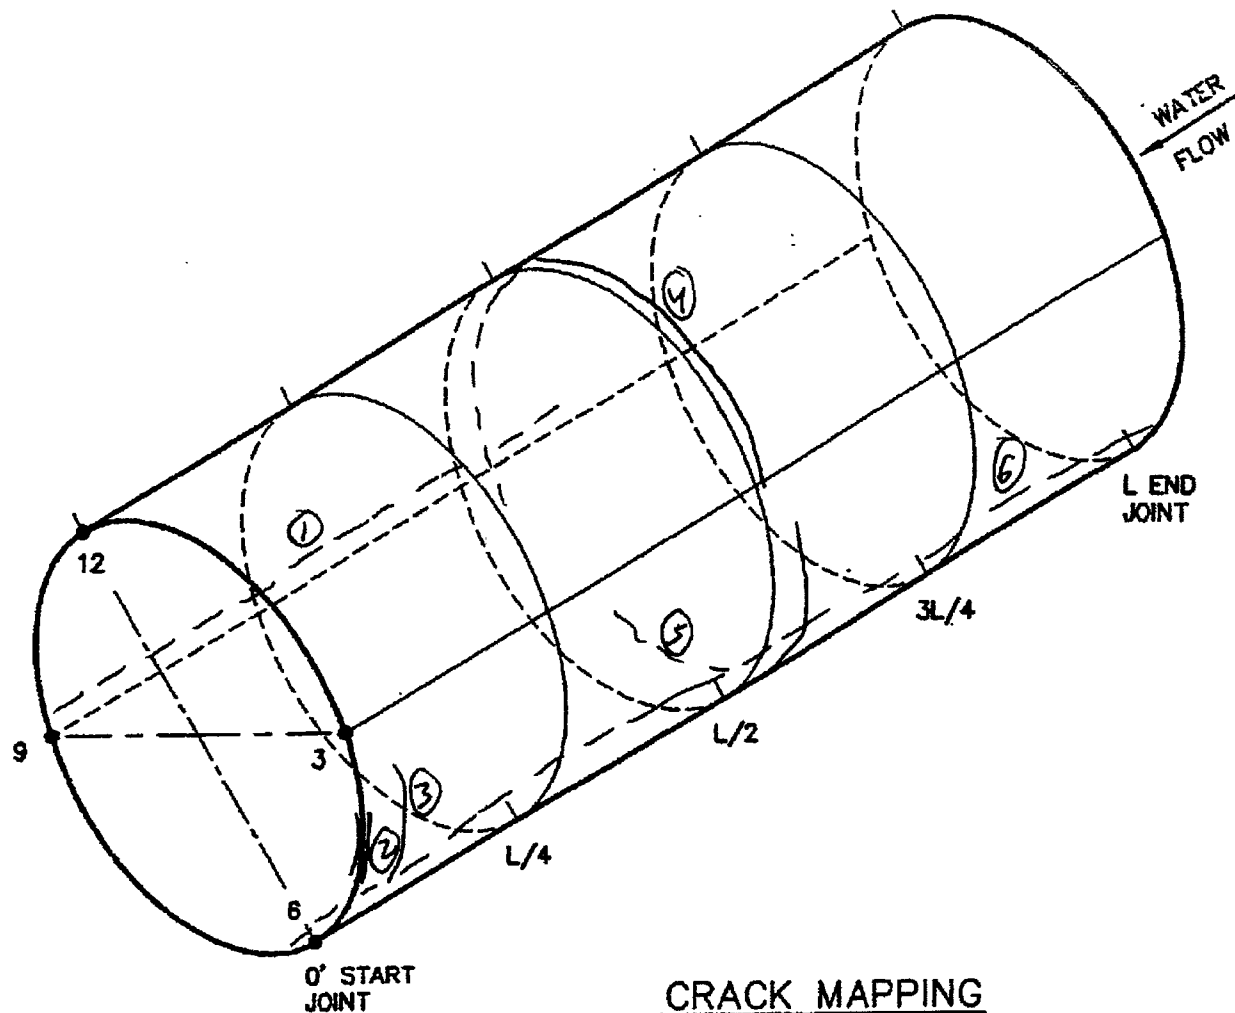
# CRACK MAPPING

CRACK NO.	LOCATION		DESCRIPTION	REMARKS
①	9	12'	LONG. CRACK	PATCH 12ft
②	3-4	1'-6"	JT. CRACK	
③	3-4	3'	MICROCRACK	
④	8-3	18'	HOOP CRACK	
⑤	3-6	8'	MICROCRACK	
⑥	6	16'	LONG. CRACK	PATCH 16ft

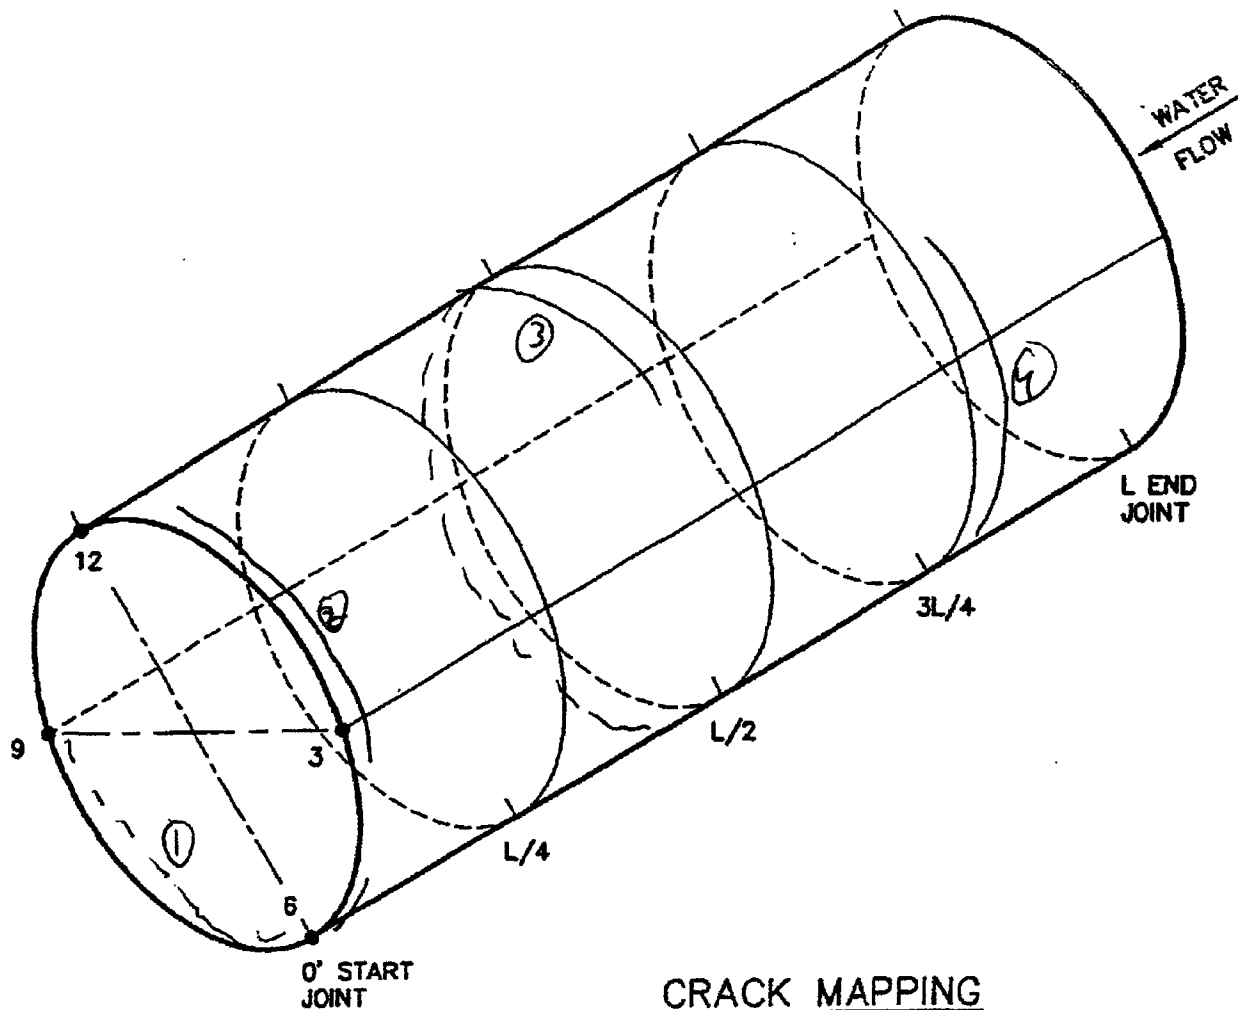
# CRACK MAPPING

CRACK NO.	LOCATION	DESCRIPTION	REMARKS
(1)	3-9 16'	ST. CRACK	
(2)	1-3 10'	MICROCRACK	
(3)	6-2 20'	HOOP CRACK	
(4)	2-5 8'	MICROCRACK

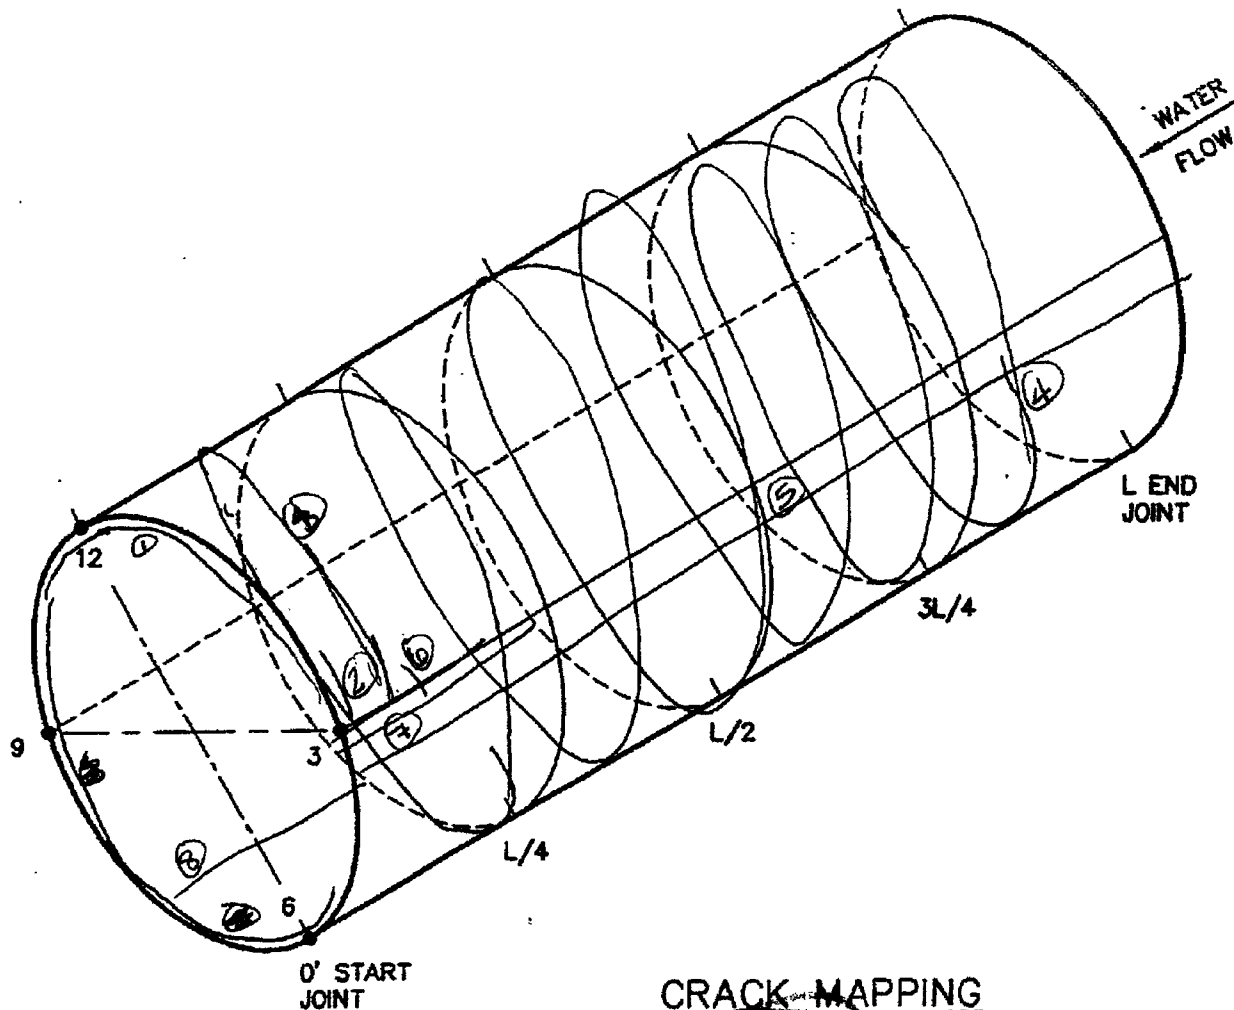
# CRACK MAPPING

CRACK NO.	LOCATION	DESCRIPTION	REMARKS
①	Start joint @ 2-5	joint/hoop crack 3/4 circ	open
2	Start joint @ 6' 3:00	open crack 1.5'	open
3	Start joint 3:00	long 2'	open
4	between 0 & 1/4 4:00-6:00	spiral crack 3/4 circ	open - 6 loops
5	Start - end 4:00	Long - full length	open
6	4/2 8:00	micro - 1.5'	
7	1/4 - 1/2 8:00	long - 3.5'	
8	0 - 1/4 7:00	long - 3'	
9	end joint 4:00-8:00	joint crack 3/4 circ	
10	Start - 1/4 4:00	long - 5'	
11	Start - 1/4 5:00	long - 6.5'	
12			
13			
14			
15			
16			
17			
18

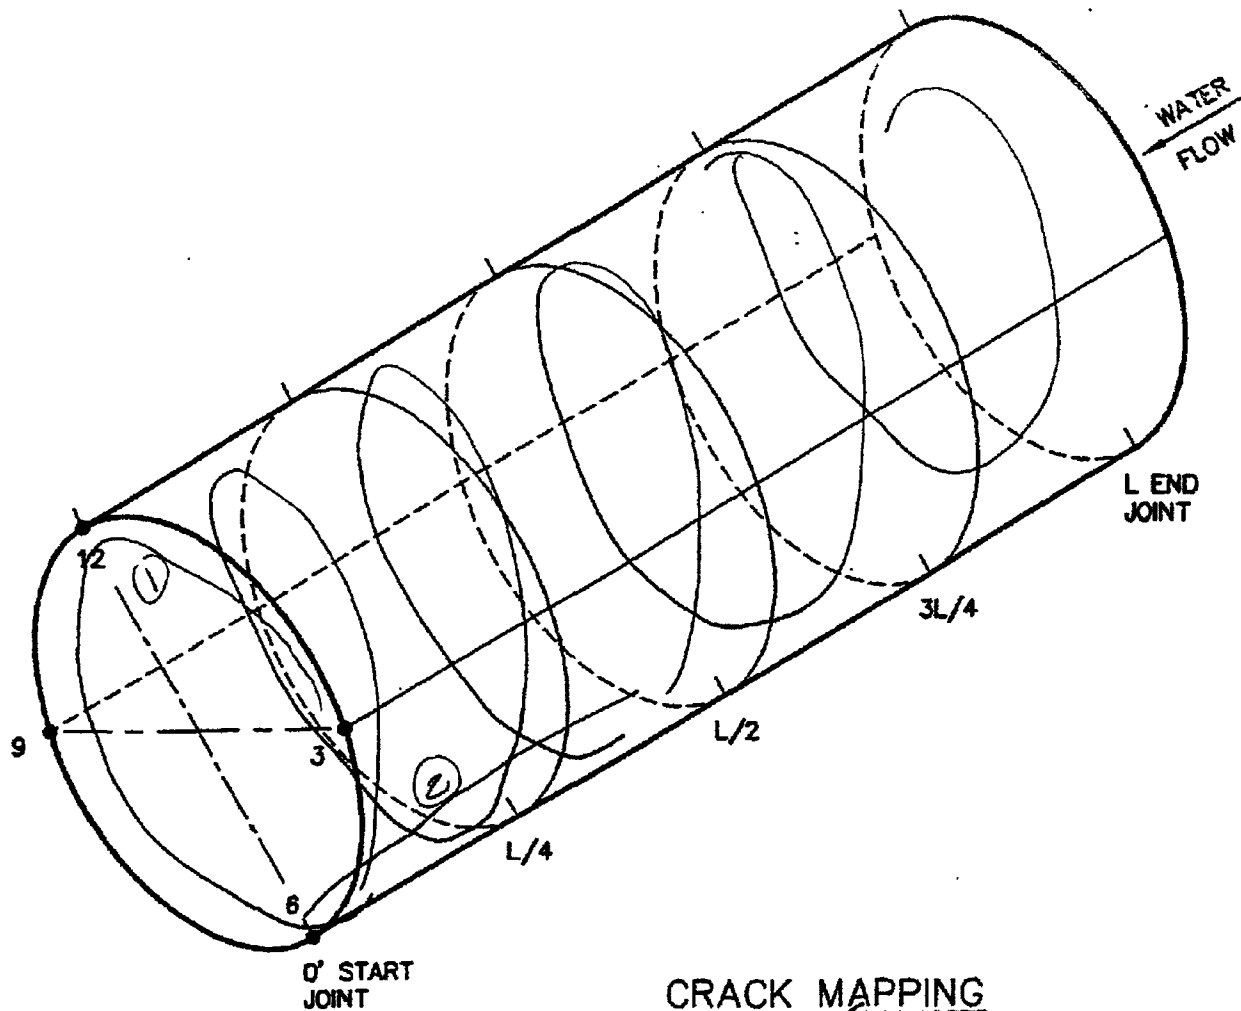
# CRACK MAPPING

CRACK NO.	LOCATION	DESCRIPTION	REMARKS
(1)	Start to end 3:00 - 4:00	Spiral crack - 5 hoops	open - conf. to pipe 61
(2)	Start - 444 6:00	long. crack - 7.5'	
(3)	344 <del>4:00 - 5:00</del> 3:00 - 4:00	micro - 4'

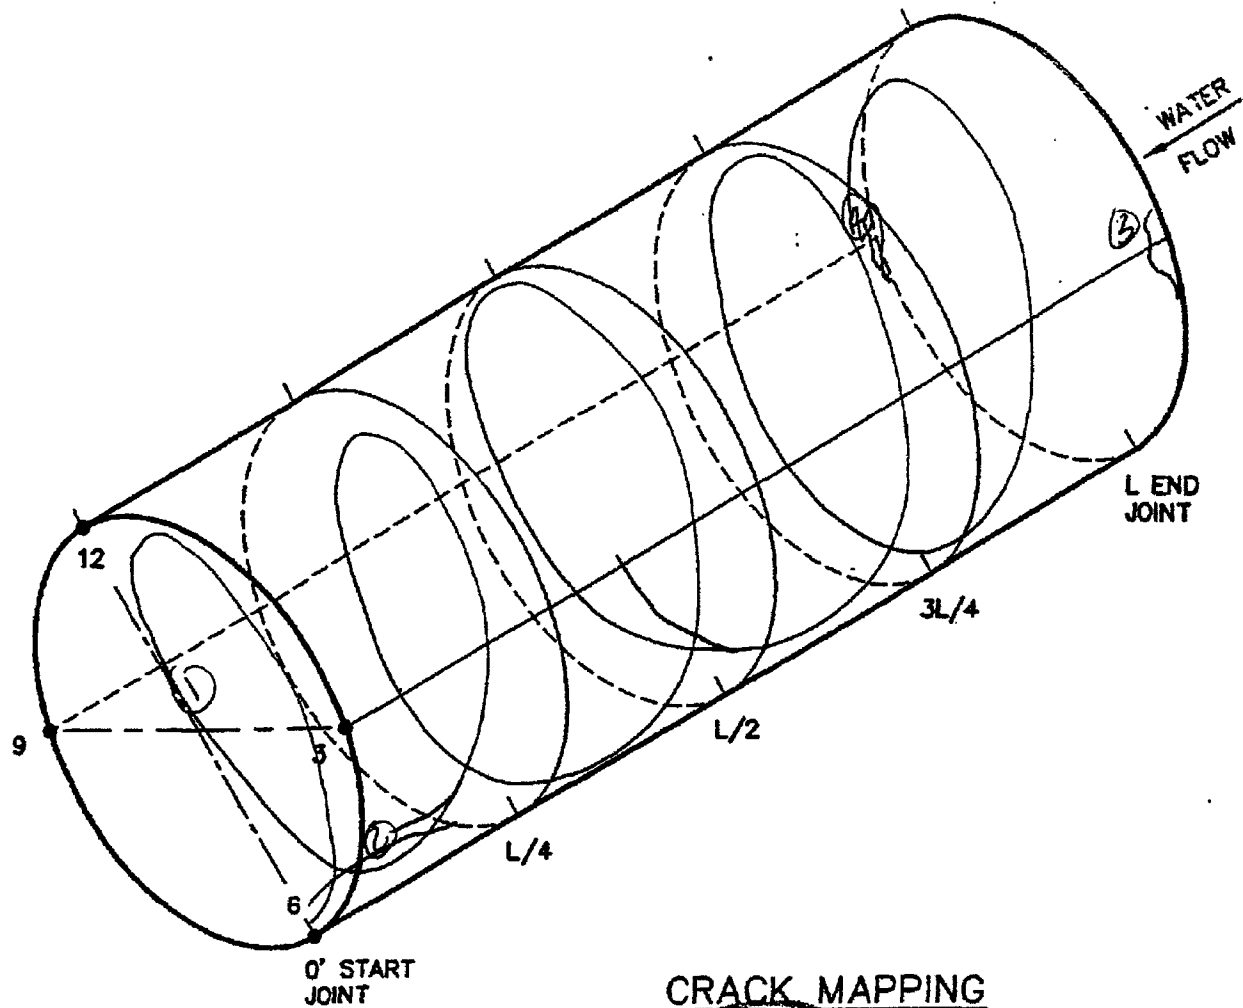
### CRACK MAPPING

CRACK NO.	LOCATION	DESCRIPTION	REMARKS
1	Start - 3/4 6:00-9:00	Spiral crack - 4 1/2 hoops open - Cont. to next pipe	damp 3'
2	Start - 4/4 6:00	long - 4.5'	damp
3	end 2:00-4:00	joint crack - 3.5'	
4	end - 9:00	joint crack - 2'

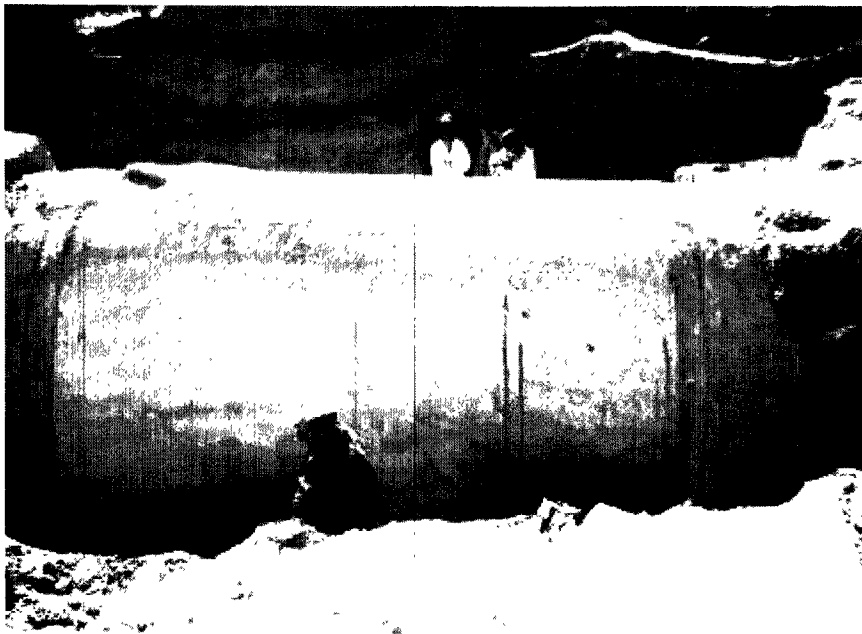
**Photo 19**

120 in. diameter Pipe #597,  
northeast side. Note two  
BWZ identified by RFEC/TC.

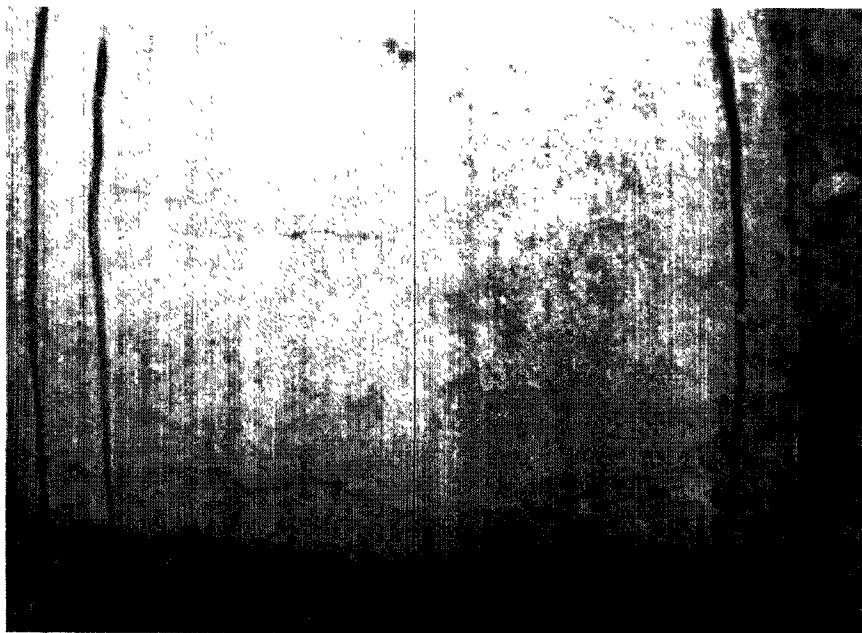
**Photo 20**

120 in. diameter Pipe #597,  
northeast side. Coating  
cracks in BWZ.
